**Subject: Final Site Assessment Report
Pilsen Soil OU2 Residential Site
Chicago, Cook County, Illinois
EPA Contract No. 68-HE-0519-D0005
Task Order (TO)—Task Order Line Item No. (TOLIN): F0069-0002AI013
Document Tracking No.: 0049**

**FINAL SITE ASSESSMENT REPORT FOR THE
PILSEN SOIL OU2 RESIDENTIAL SITE
41 RESIDENTIAL PROPERTIES
CHICAGO, COOK COUNTY, ILLINOIS 60608**

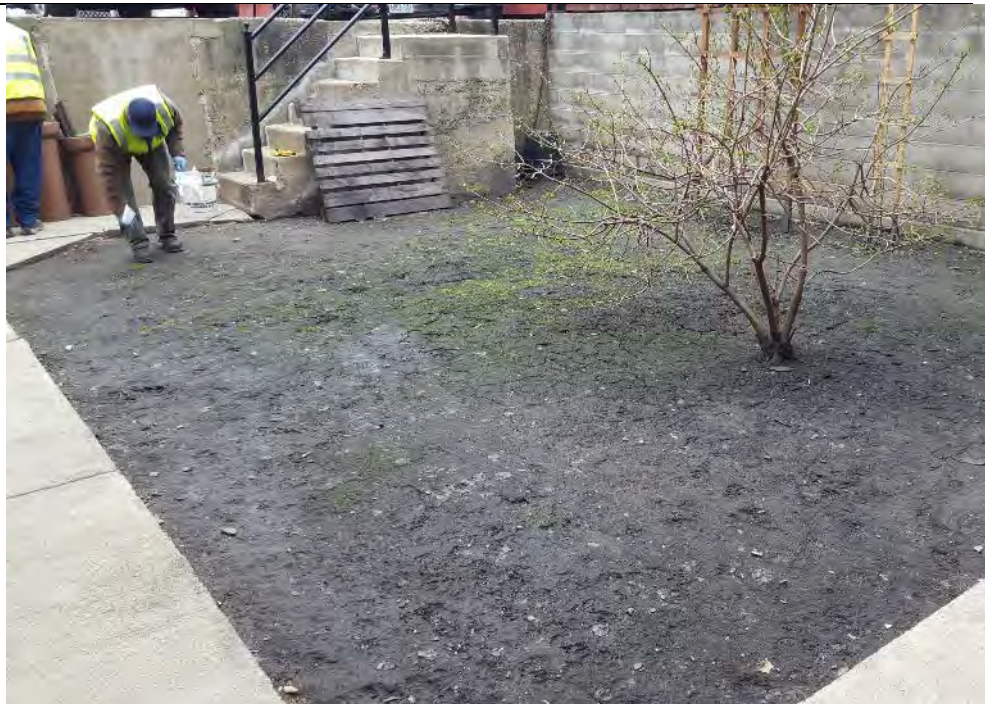
Description:
View of GHD placing pin flags for a composite sample in the back yard area of Non-Responsive

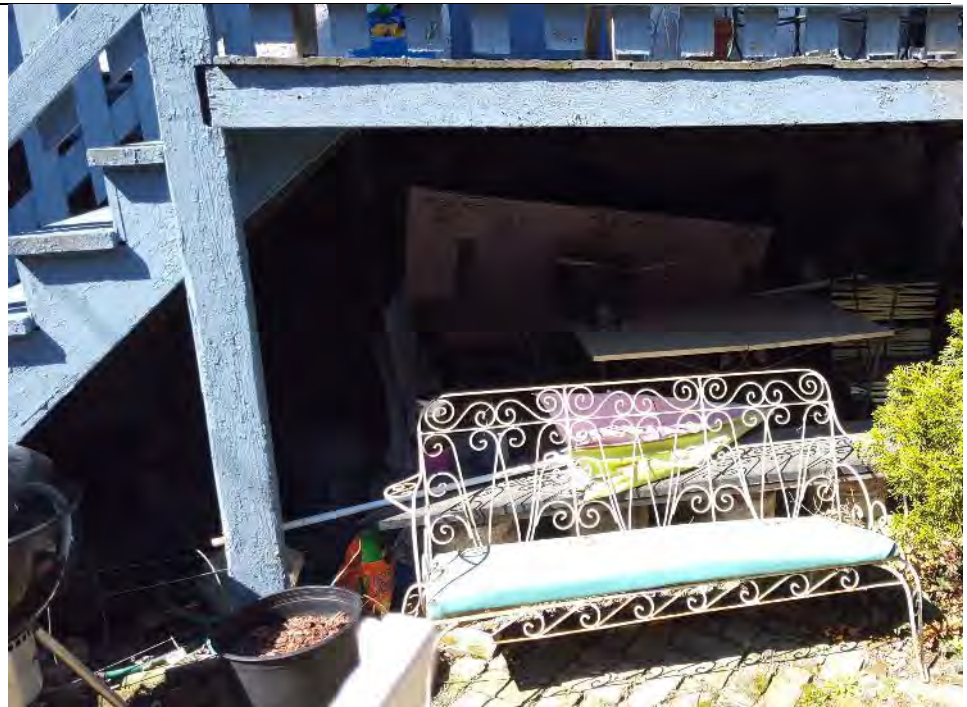
View of inaccessible soil area under a wooden porch at Non-Responsive

Non-Responsive
Area was not sampled by GHD.

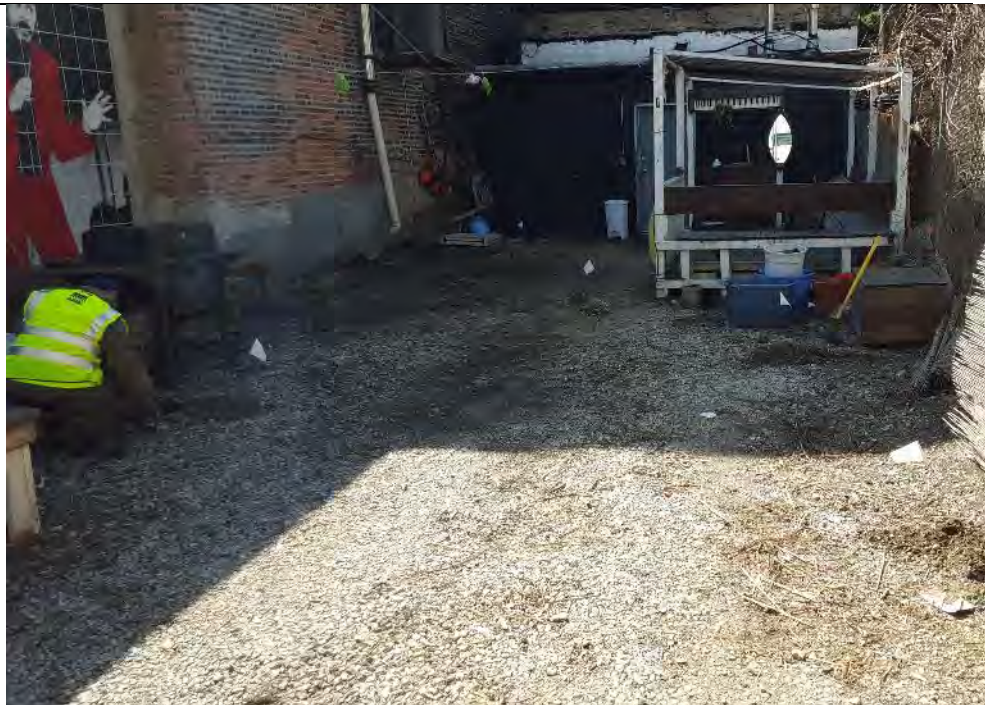
View of GHD collecting a 5 point composite sample beneath a surficial gravel layer in the backyard of

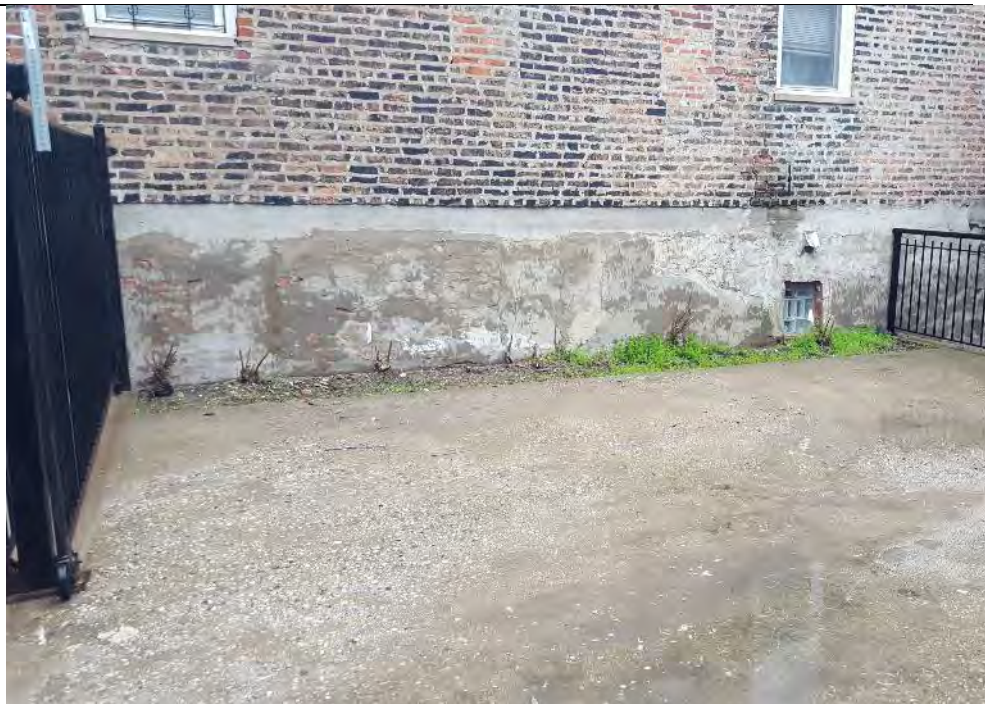
Soil strip to the north of the parking area sampled by GHD as a 2 point composite sample.

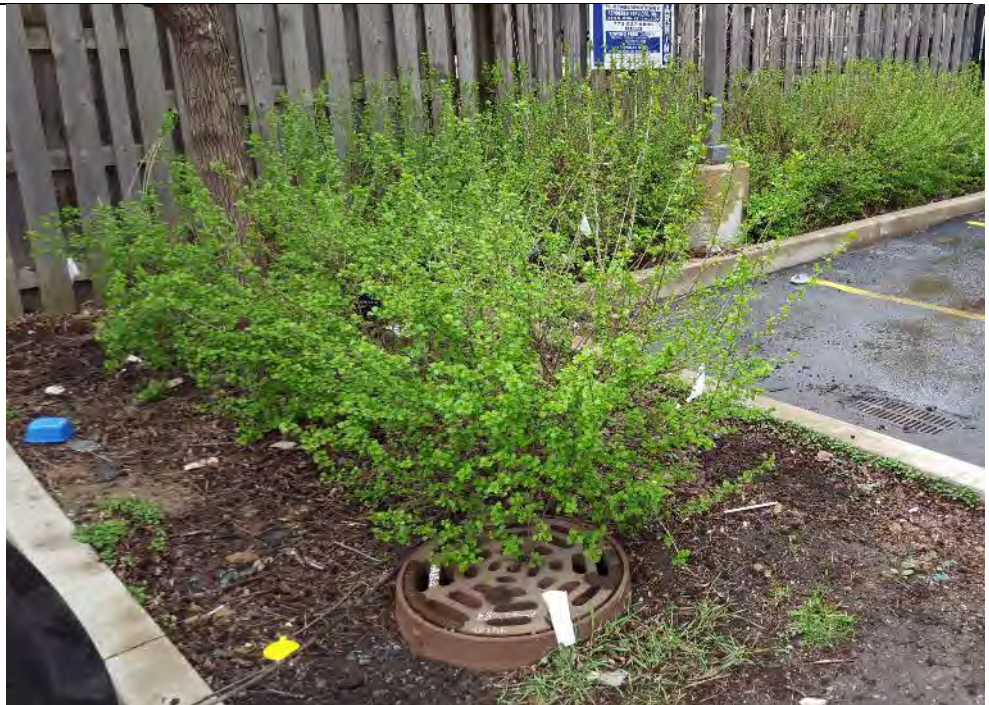
View of 5 point
composite sample
locations in soil area
around parking lot in
back yard of [Non-Responsive]

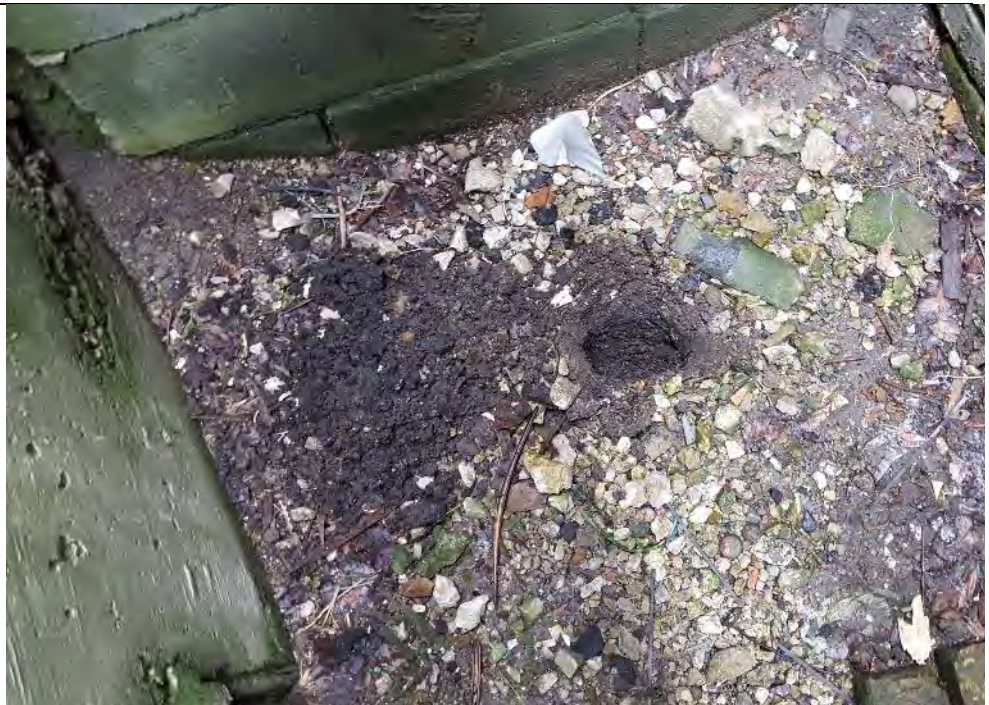
Description:
View of debris in vicinity of a 2 point composite sample collected from the back yard area of [Non-Responsive]
[Non-Responsive]

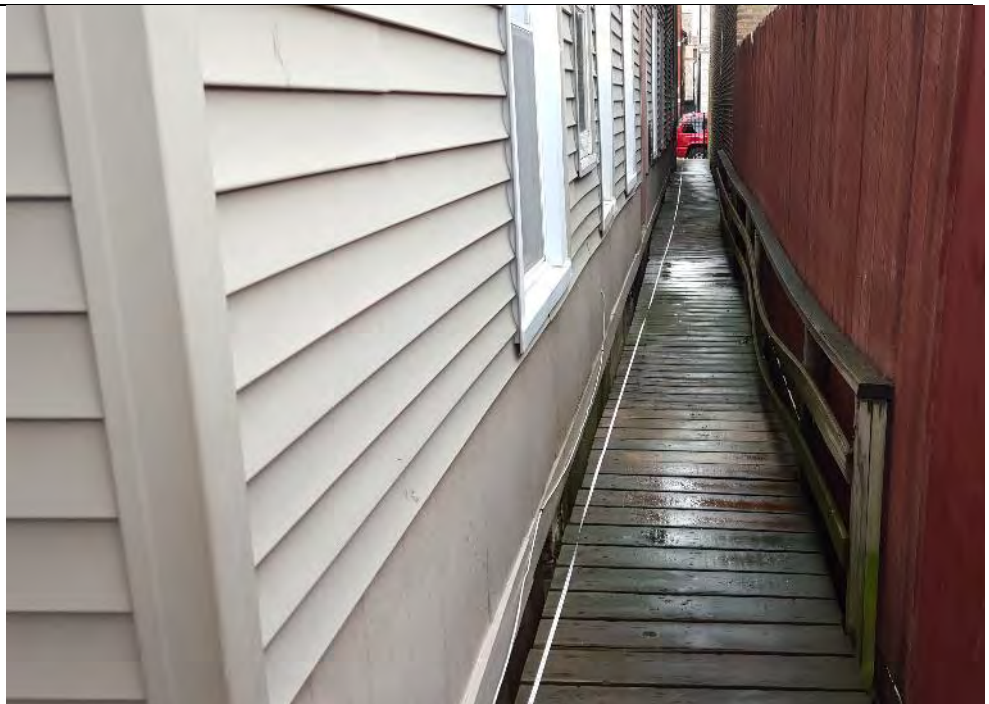
Description: View of elevated walkway above a soil area on the south side of [Non-Responsive]
[Non-Responsive] Soil area underneath was inaccessible and was not sampled by GHD.

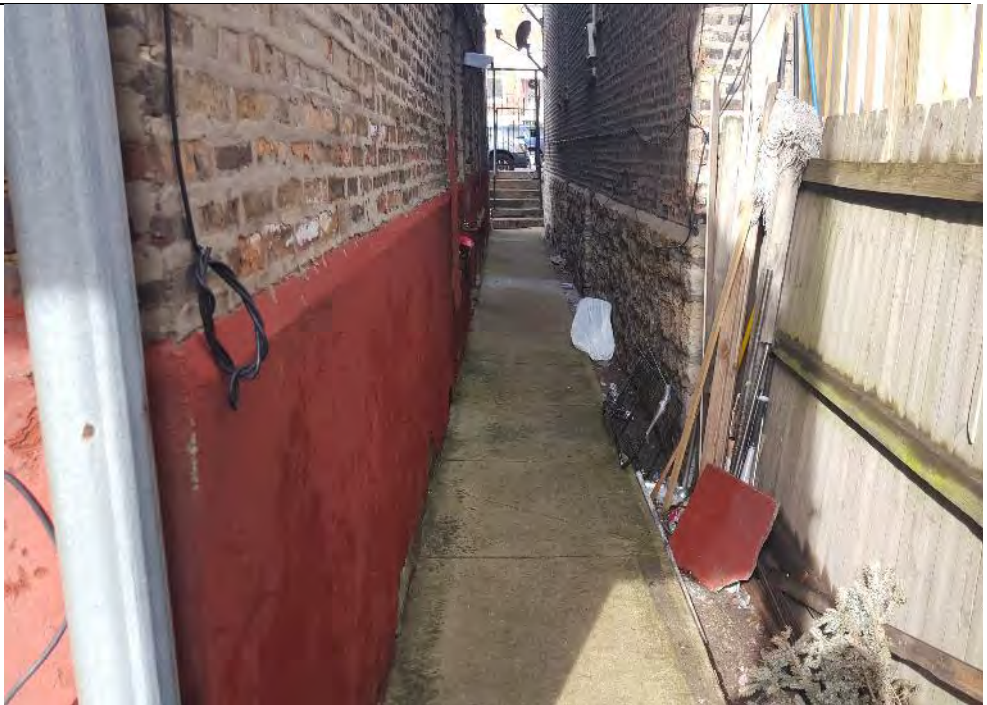
View of soil strip on the north side of the walkway on the north side of [Non-Responsive] GHD did not collect a sample as the soil area matched the description of a small soil strip in a drip area and walkway.

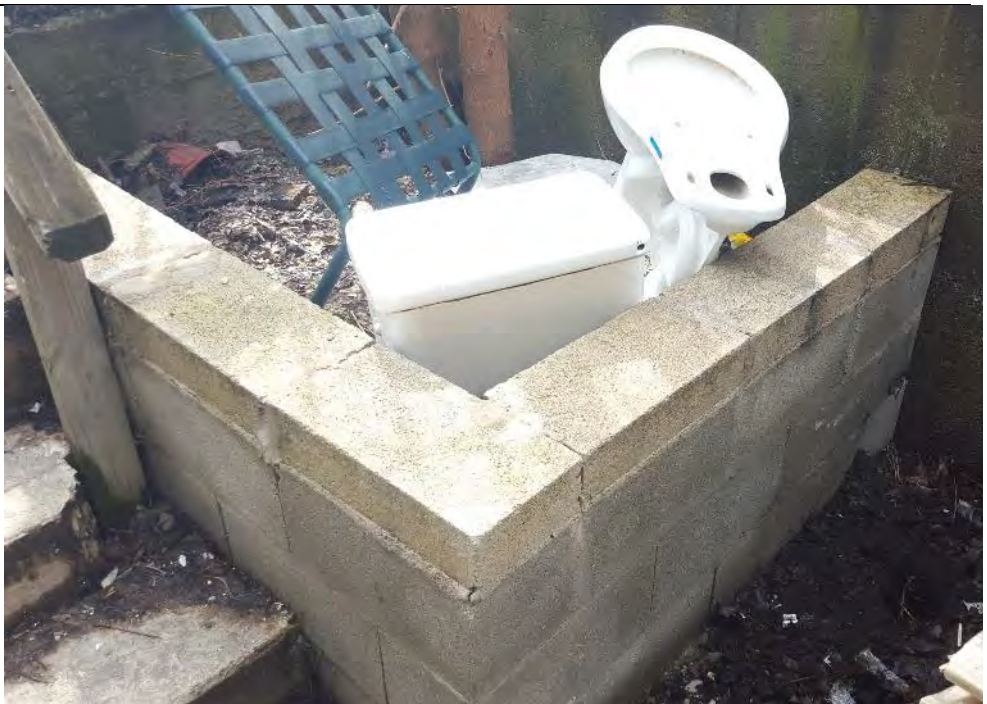
Description: View of 1 of 4 elevated garden boxes on the south side of the back yard of [Non-Responsive] GHD did not collect soil samples from the elevated gardens as the property owner filled them with new soil.

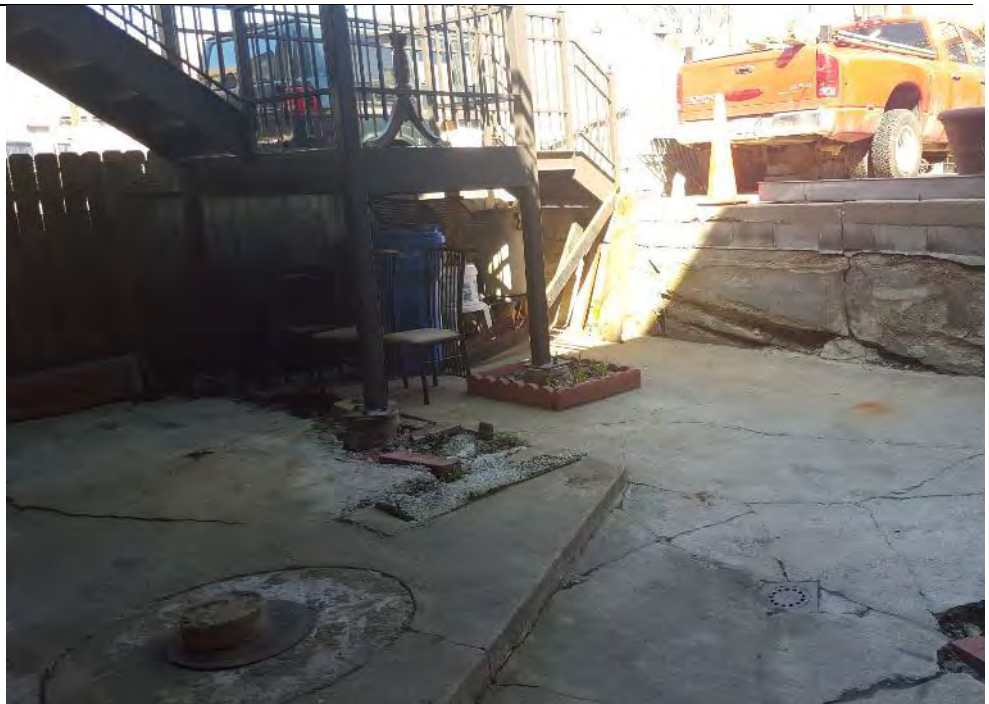
Description: View of concrete covered back yard of [Non-Responsive] GHD did not collect soil samples from the property as new soil was placed in raised gardens in the front yard and the back yard was covered with concrete.

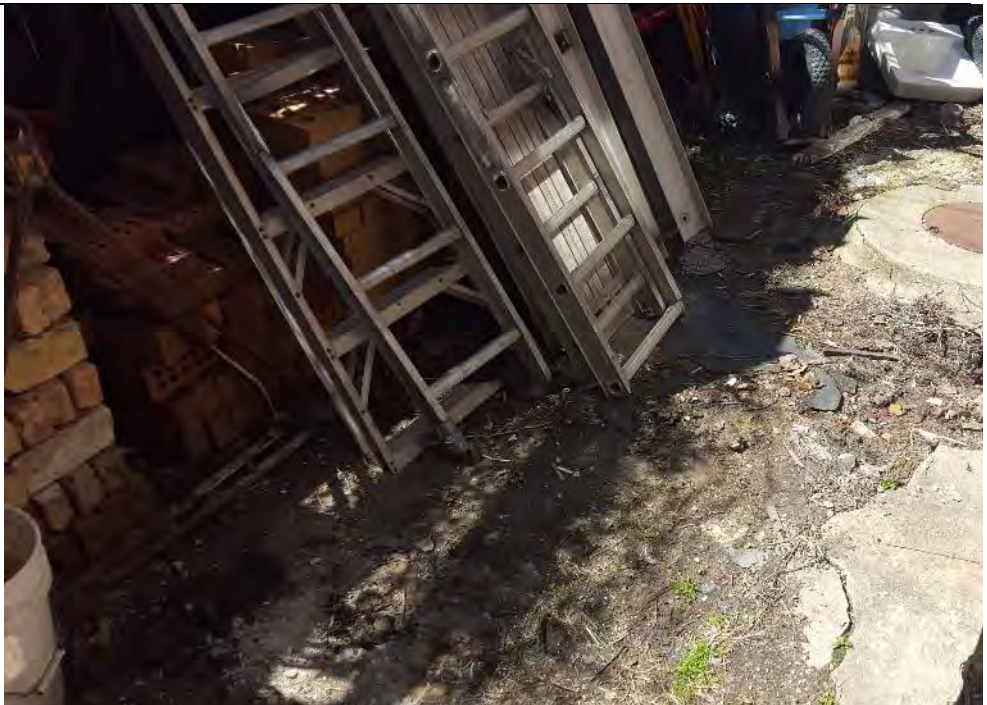
View of shallow soil in a lower portion of the back yard at [Non-Responsive] GHD did not collect a sample from this area as the soil cover was shallow runoff onto a concrete pad.

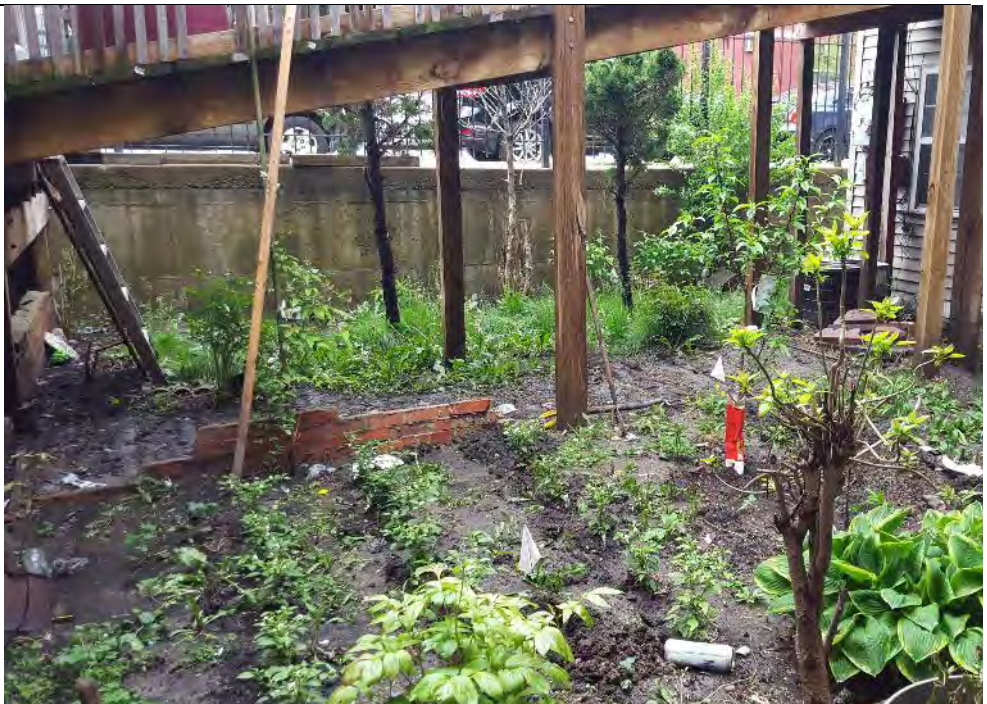
Description: View of 5 point composite sample locations in back yard garden of [Non-Responsive]

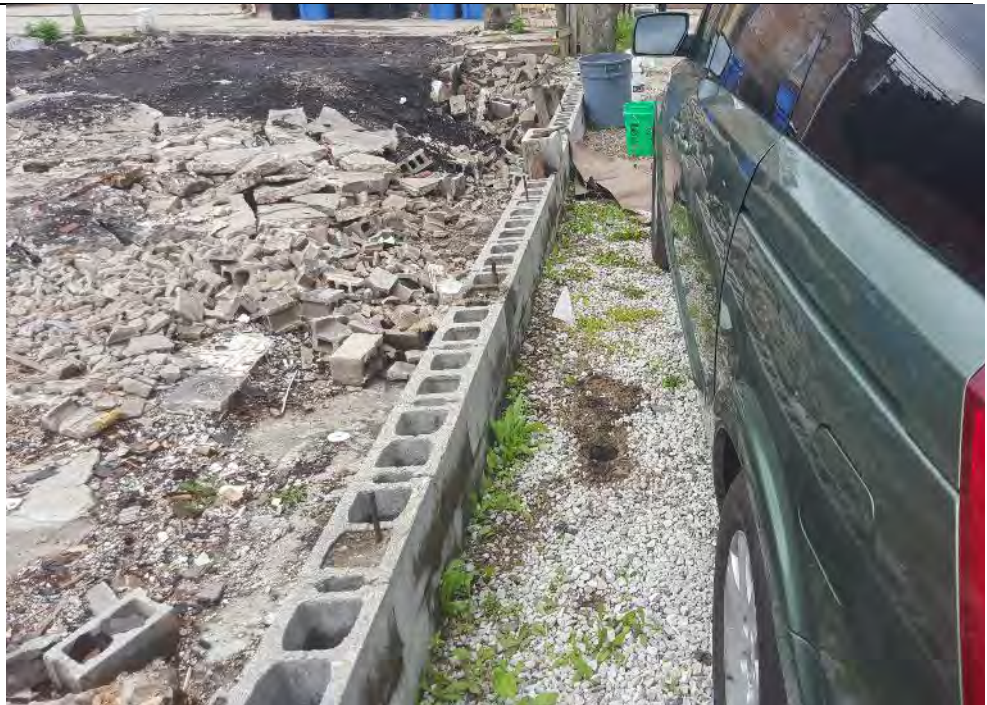
Description:
View of composite
sample collection
beneath surficial gravel
layer in parking area in
back yard of
Non-Responsive

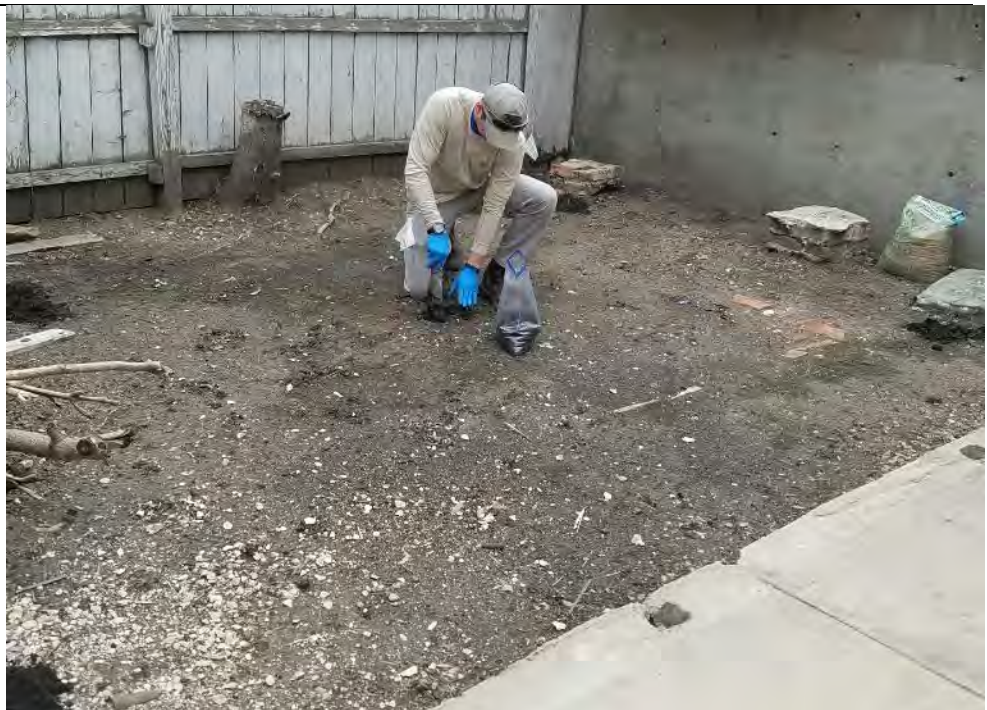
Description: View of
GHD collecting a 5
point composite sample
from the back yard of
Non-Responsive
